Technical Bulletin

Bulletin #: 011017

Issue Date: January, 10 2017

Replacing a ½ HP Baldor Motor with a Marathon Motor

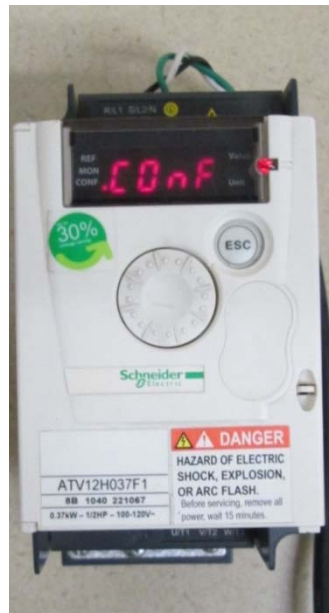
This bulletin outlines what VFD changes need to be made when you replace your Baldor ½ HP motor with a Marathon motor. The part number this applies to is 015225. The reason this has changed is because the efficiency standards for the year 2016 and newer are increased.

Low torque compensation.

1. Locate the corresponding VFD for the motor that was replaced.
2. Click and release the round setup dial, then lightly rotate to **CO nF**.
3. Press the round setup dial and, then lightly rotate to **FULL**.
4. Press the round setup dial and, then lightly rotate to **DrC**.
5. Press the round setup dial and, then lightly rotate to **uFr**.
6. Press the round setup dial. **100** will display as the parameter. Rotate the dial to **50**. Press the setup dial to set the new value.
7. Press **Esc** 4 times to return back to ready mode.
