Bulletin #: 031722-01

Issue Date: March 17, 2022

S-Carriage Setup

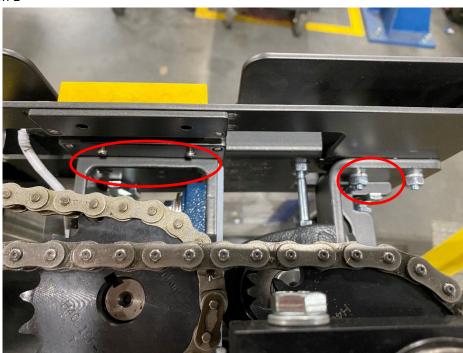
1. Jack bolt and bearings for the door-mounted prestretch roller should be loose to start (to allow adjustment toward or away from the door). Door latches should be set to hold door firmly against hard stop locations circled in red in the illustrations below (see illustration 1, 2, and 3).

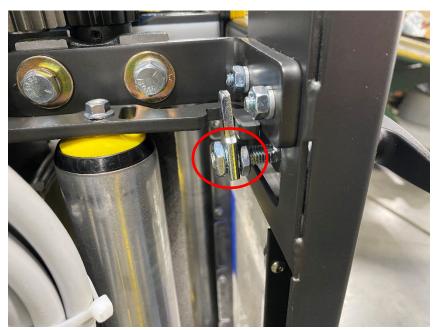
2. Ensure all mounting nuts, circled in red in the illustrations below, for the handles and latches are tight (see illustrations 4, 5, and 6). Illustration 4

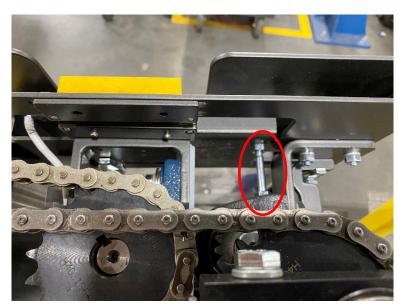
Illustration 7 (Jack Bolt)

3. Close and latch the door. Adjust the door-mounted prestretch roller using the jack bolt for the top bearing and sliding the bottom bearing in its slots. When a snug gear mesh is achieved, tighten the jam nut on the jack bolt as well as the hardware in each bearing base to hold the roller in position (see illustrations 7, 8, and 9).

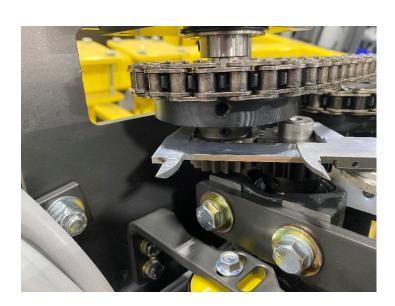
4. Verify setup. Typically, if the gears do not mesh correctly, there is a very noticeable, audible difference while the carriage is running. The carriage may become louder, or there may be a repeating "clunk" noise or "chatter" if the gears are able to skip past each other. A measurement can be done with a caliper as a quick verification, although this is typically unnecessary. Per the illustrations below, measure from the outside of the drive gear's hub to the outside of the door-mounted prestretch roller's shaft (see illustrations 10, 11, and 12). The measurement for an acceptable mesh should be 2.624 ± 0.015 inches. Measurements outside this range may still be acceptable for reliable operation but could result in faster wear of the gear(s). Note: this is a difficult measurement to obtain accurately with the carriage fully assembled and while important, it's mainly to be used as a reference.
