Technical Bulletin

Bulletin #: V120909-01

MicroLogix 1400 Firmware Problem

Micrologix 1400 Firmware Upgrade

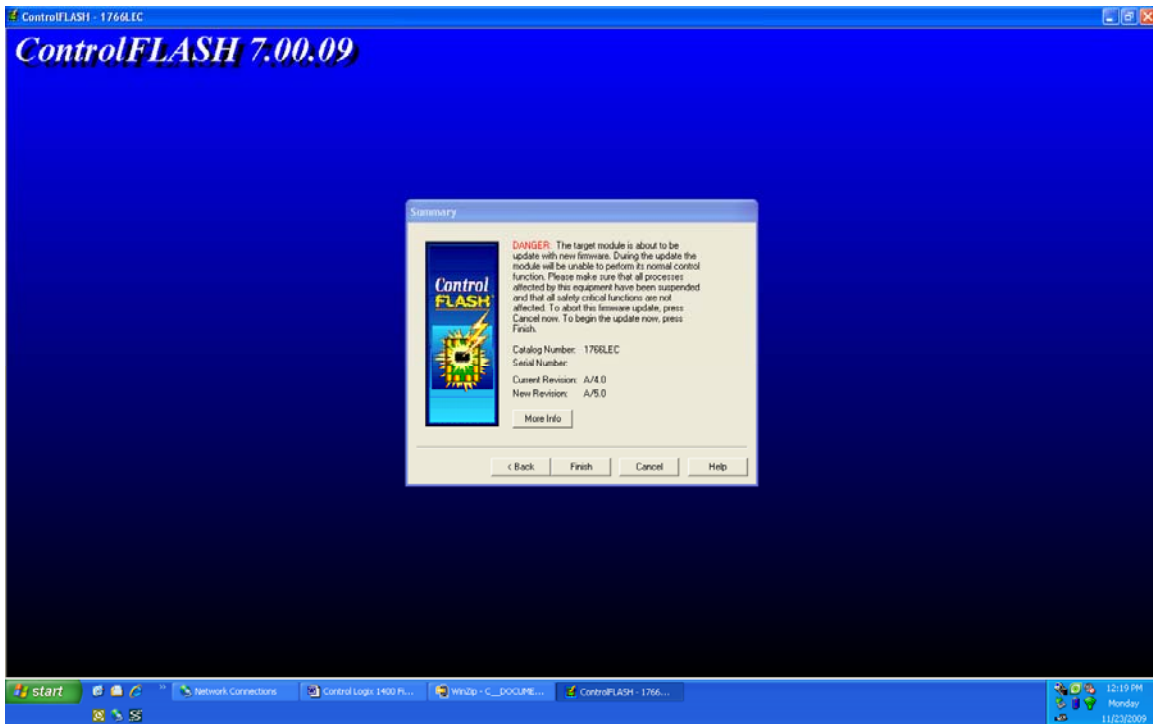
STEP 11

The next screen contains a message explaining that downloading the Firmware will interrupt PLC operation. Make sure the machine is not running and an E-Stop is pressed. Then select “Finish”
